Report Title:	Preliminary Geotechnical Investigation Report: Proposed Master Plan Development, Barton Park, Bestic Street, Banksia New South Wales.				
Doc. Ref:	E17011-CU-15-R				
Client:	Prepared for MODE Design Corp Pty Lt	rd			
	Prepared By: Authorised By:				
Signature:	S.me	WW			
	Stephen McCormack, Principal Geotechnical Engineer B.E. (Civil) — CPEng, MIEAust, NER (geotechnical)	Dr Michael Petrozzi, Managing Director

Preliminary Geotechnical Investigation Report: Proposed Master Plan Development Barton Park, Bestic Street, Banksia New South Wales.

Report ID: E17011-CU-15-R. Prepared for MODE Design Corp Pty Ltd.

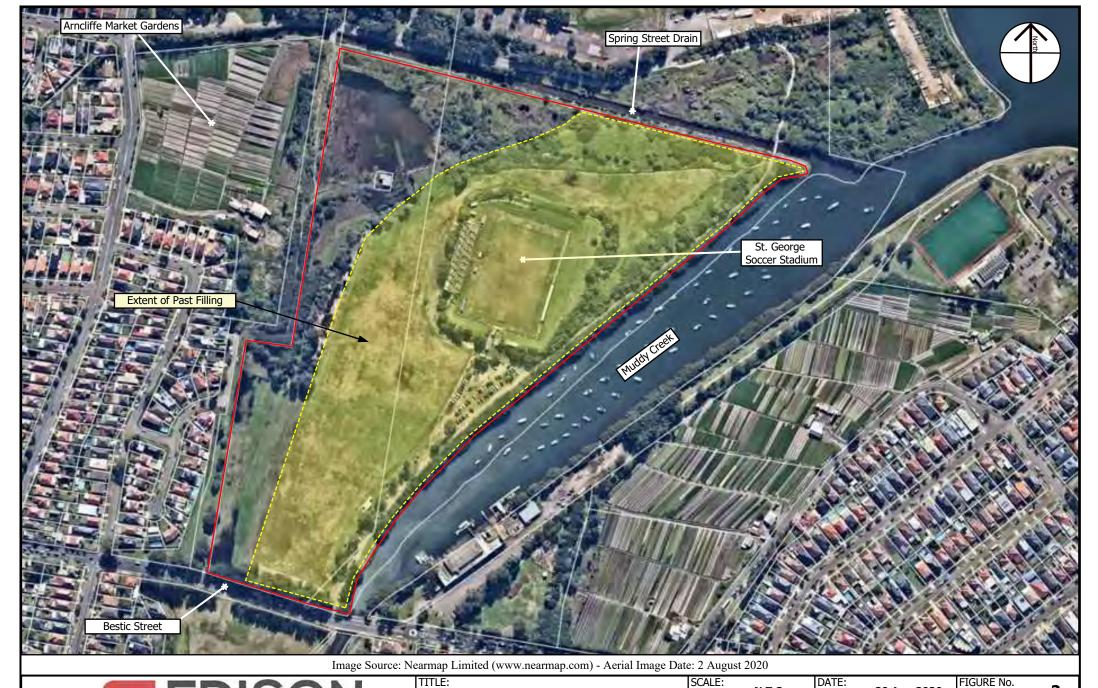
SCALE:
 N.T.S
 DATE:
 20 Aug 2020
 FIGURE No.
 2

SITE PLAN
Barton Park, Bestic Street, Rockdale NSW

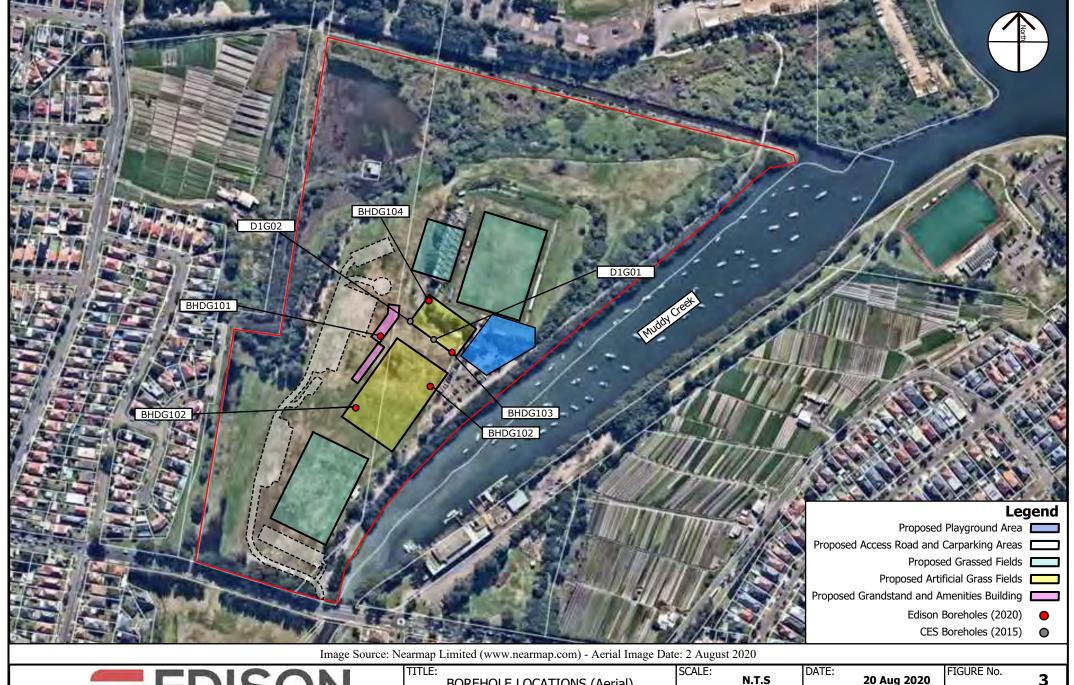
SCALE:
 N.T.S
 DATE:
 20 Aug 2020
 FIGURE No.
 3

BOREHOLE LOCATIONS (Aerial)
Barton Park, Bestic Street, Rockdale NSW

- Drilling and logging of one (1) borehole (BHDG101) within the approximately footprint of the proposed tiered seating area and amenities building to provide a preliminary assessment of the fill/soil conditions and the depth to bedrock at this location (Figures 3 and 4);

- Performance of Standard Penetration Tests (SPTs) in borehole BHDG101 to assess the consistency and/or relative density of the soil profile;
- Drilling and logging of four boreholes (BHDG102 to BHDG105) within the approximately footprint of the proposed new artificial grass fields to complement the existing information and to provide an additional assessment of the shallow fill/soil conditions (Figures 3 and 4);

A summary of the subsurface conditions encountered is provided in Section 5.1, while a summary of the borehole information, including total depth, depth of fill and depth to bedrock, is provided in Table 1. The locations of the boreholes are shown on Figure 3 along with a recent aerial photograph and Figure 4 also shows the proposed masterplan.

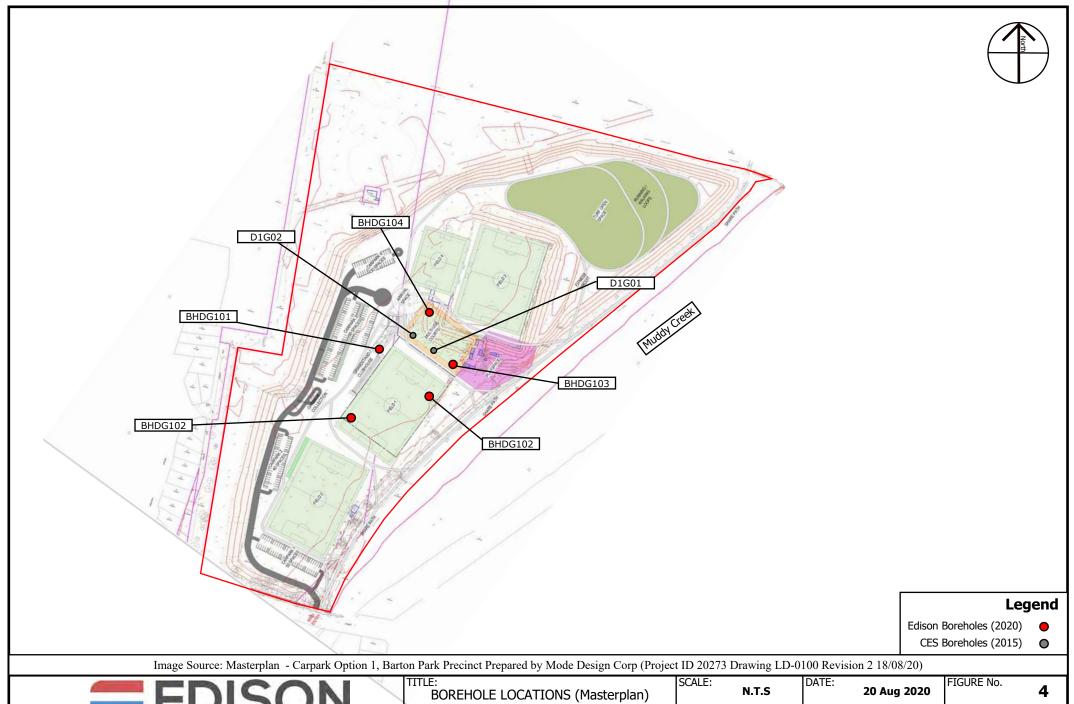
BOREHOLE LOCATIONS (Masterplan) DRAWN: JOB No.: REVISION: Barton Park, Bestic Street, Rockdale NSW S. McC E17011-CU Α

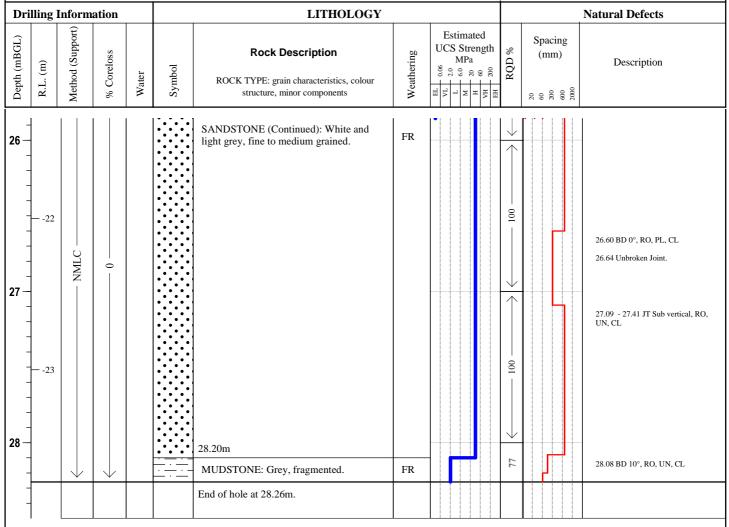
Groundwater Monitoring Well Installation

Gatic Cover at the surface. Casing: 0.0 - 2.0m Screen: 2.0 - 6.0m Concrete: 0.0 - 0.2m Bentonite Plug: 0.2 - 1.2m Sand Filter: 1.2 - 7.0m Bentonite Plug: 7.0 - 8.5m

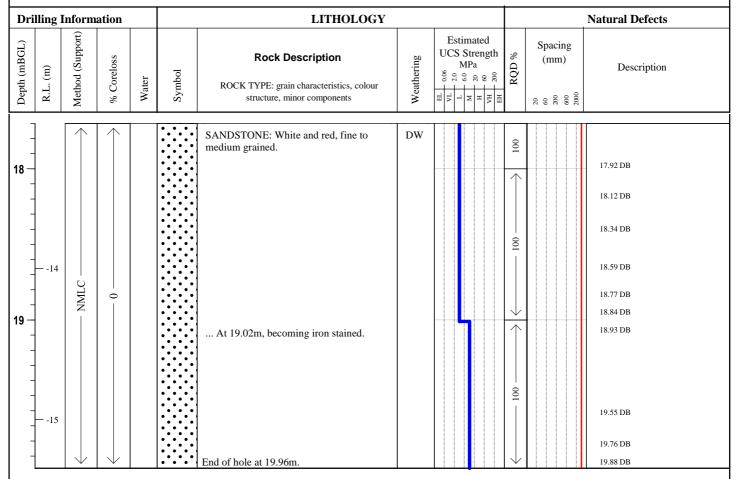
Groundwater Monitoring Well Installation

Gatic Cover at the surface. Casing: 0.0 - 2.0m Screen: 2.0 - 6.0m Concrete: 0.0 - 0.2m Sand Backfill: 0.2 - 0.5m Bentonite Plug: 0.5 - 1.5m Sand Filter: 1.5 - 8.0m Bentonite Plug: 8.0 - 9.5m

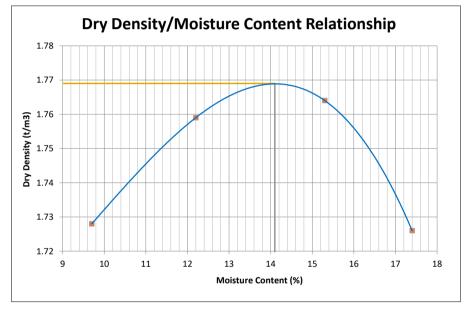
DRY DENSITY / OPTIMUM MOISTURE CONTENT REPORT						
Client	Geo-Environmental Engineering	Source	G3			
Address	82 Bridge Street Lane Cove 2066	Sample Description	Silty SAND			
Project	Geotechnical Investigation (G20067ROC)	Report No	S63129-MDD			
Job No	S20380	Sample No	S63129			
Test Procedure: AS1289.5.1.1 Dry Density / Moisture Content Relationship - Standard Compaction AS1289.2.1.1 Moisture Content - Oven Drying Method (Standard Method)						
Sampling:	Sampled by Client - results apply to the sample as rec	eived	Date Sampled: 17/08/2020			
Preparation:	Prepared in accordance with the test method					
	·

Maximum Dry Density (t/m³)	1.769
Optimum Moisture Content (%)	14.1
Oversize Retained on 19mm sieve (%)	3.1
Oversize Retained on 37.5mm sieve (%)	0.0
Curing Time	29 hrs
Liquid Limit Determination	Technician Assessment

Sample ID	Sample Location / Depth (m)	Sample Description	CBR Value (%)	Optimum Moisture	Maximum Dry Density
	•	• 1	5.0mm	Content (%)	(t/m³)
G3	BHDG103/0.2 – 1.2m	SAND with minor silt and gravel	40.0	14.1	1.769
G4/G5	BHDG104 & BHDG105/0.2 -1.0m	Gravelly SAND and SAND	35.0	11.9	1.87

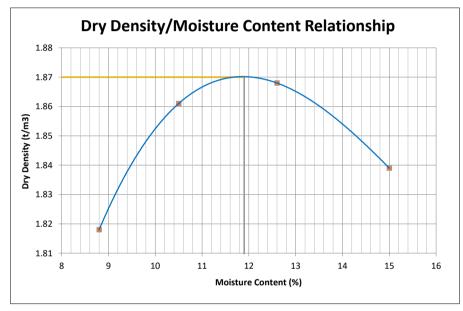
DRY DENSITY / OPTIMUM MOISTURE CONTENT REPORT						
Client	Geo-Environmental Engineering	Source	G4-G5			
Address	82 Bridge Street Lane Cove 2066	Sample Description	Silty Gravelly SAND			
Project	Geotechnical Investigation (G20067ROC)	Report No	S63130-I	MDD		
Job No	S20380	Sample No	S63130			
Test Procedure: AS1289.5.1.1 Dry Density / Moisture Content Relationship - Standard Compaction AS1289.2.1.1 Moisture Content - Oven Drying Method (Standard Method)						
Sampling:	Sampled by Client - results apply to the sample as re	eceived		Date Sampled:	17/08/2020	
Preparation:	Prepared in accordance with the test method

Maximum Dry Density (t/m³)	1.870
Optimum Moisture Content (%)	11.9
Oversize Retained on 19mm sieve (%)	3.8
Oversize Retained on 37.5mm sieve (%)	0.0
Curing Time	28 hrs
Liquid Limit Determination	Technician Assessment
