Report Title:	Sampling, Analysis and Quality Plan (SAQP), Preliminary Environmental Site Assessment, Portion of Barton Park occupied by Former St George Soccer Stadium, Banksia, New South Wales.				
Doc. Ref:	E17011-CU-14-SAQP				
Client:	Prepared for MODE Design Corp Pty Ltd				
Signature:	Authorised By:				
	Dr Michael Petrozzi, Managing Director Certified Environmental Practitioner No. 1176 Site Contamination Specialist No. SC40121

Sampling, Analysis and Quality Plan (SAQP): Preliminary Environmental Site Assessment, Portion of Barton Park Occupied by Former St George Soccer Stadium, Banksia, New South Wales.

Report ID: E17011-CU-14-SAQP. Prepared for MODE Design Corp Pty Ltd.

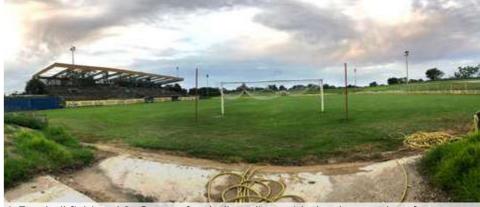
1: Football field and St George football stadium with the damaged roof structure

There is little change except that the stadium roof has been removed due to structural failure. The structure remains but the building is closed off to the public due to concerns for public safety. The grounds continue to be operated by the St George Soccer Club.

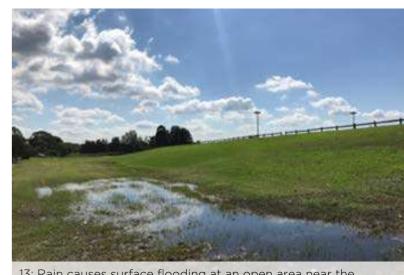
13: Rain causes surface flooding at an open area near the residential zone

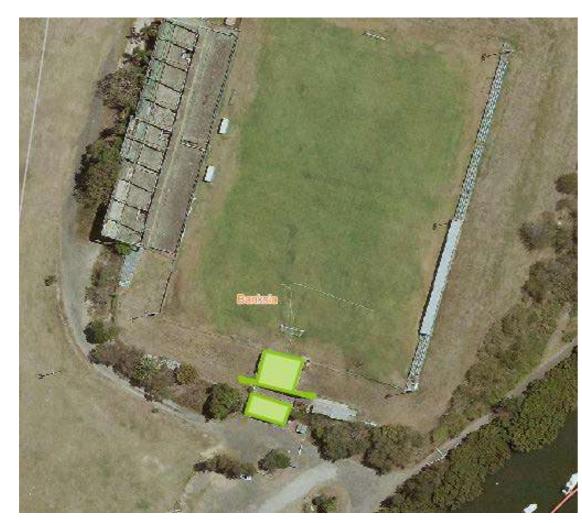
Figure 2.4 - Map showing buildings demolished in 2019

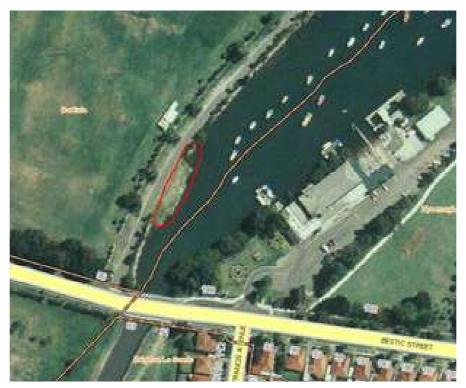
Figure 2.8 - Year 2000 aerial photograph shows extension of bank of Muddy Creek. This has effectively added reclaimed land to the banks of Barton Park

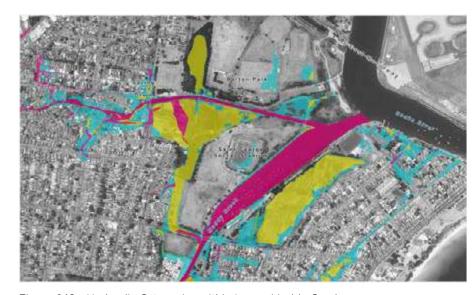
Figure 2.10 - Hydraulic Categories within Lower Muddy Creek

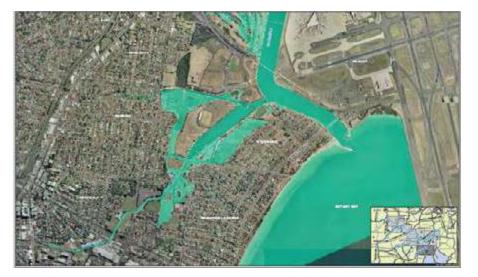
Figure 2.11 - Extent of 1:100 Year flood of Lower Muddy Creek Catchment

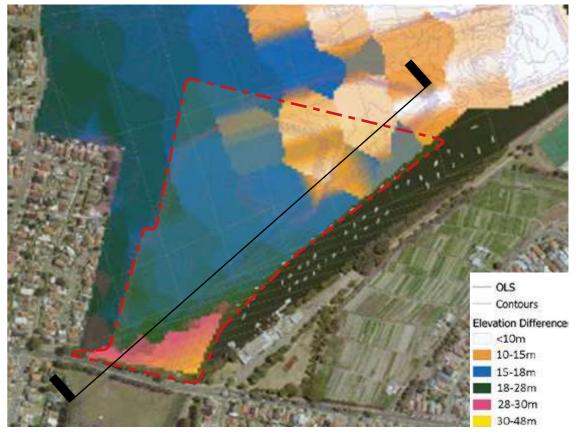
Figure 2.13 - Mapping of OLS (Gap analysis between OLS and AHD contours

The OLS is defined by international specifications, as adopted by CASA. It defines the airspace surrounding an airport that must be protected from obstacles to ensure aircraft flying in good weather during the initial and final stages of flight, or in the vicinity of the airport, can do so safely. Figure 2.13 Mapping of OLS (Gap analysis between OLS and AHD contours) identifies the constraints of the OLS as it impacts the heights of structures to under 10m in some sections of the park that can be constructed within Barton Park.

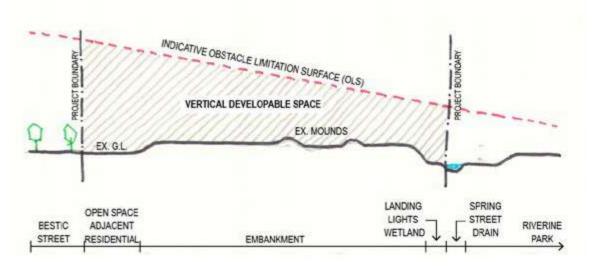
Figure 2.14 - Indicative Section - Vertical Developable Space

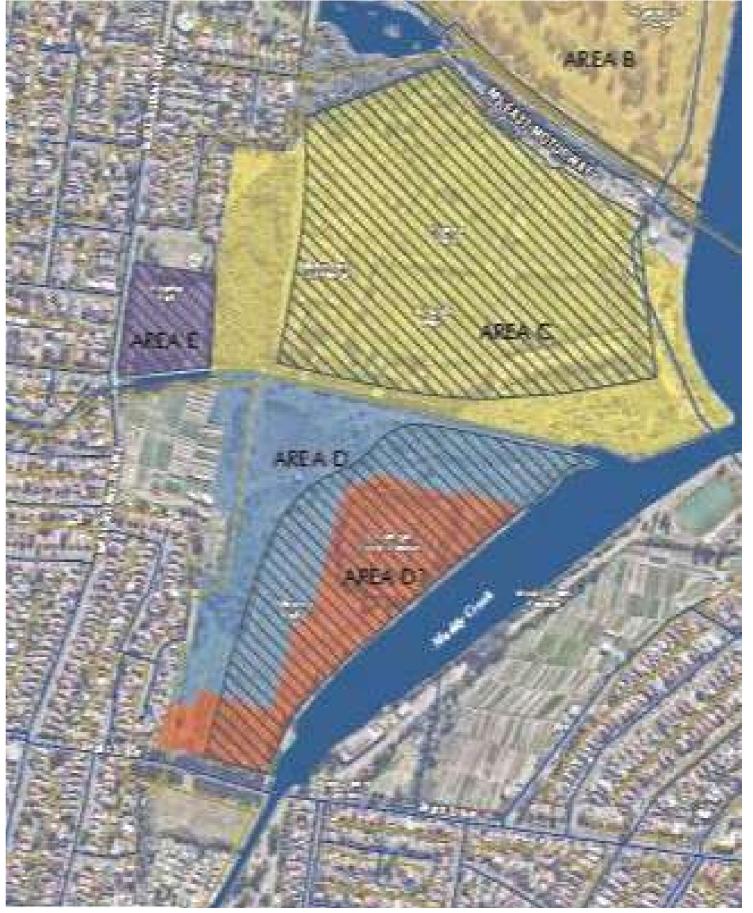
Figure 2.17 - Hatched Areas subject to historical land fill
